Intel[®] Mobile Celeron[™] Processor at 466 MHz, 433 MHz, 400 MHz, 366 MHz, 333 MHz, 300 MHz, and 266 MHz Specification Update

Release Date: August 2000

Order Number: 244444-017

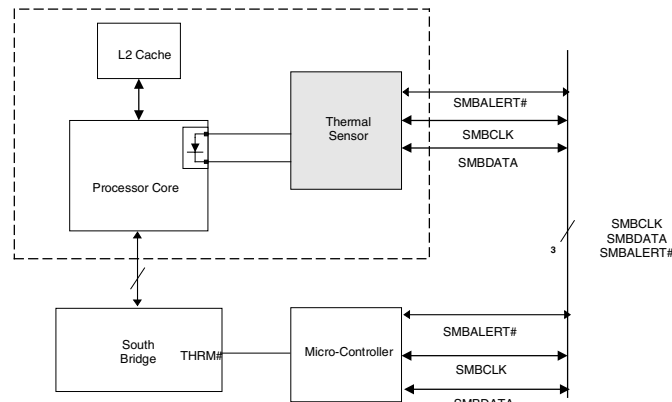
Figure 1. An Example of Microcontroller Driven Thermal Management

H29. Thermal Sensor May Assert SMBALERT# Incorrectly

Problem: The Intel Celeron Processor Mobile Module has a thermal sensor that monitors the processor core's temperature. Please note that desktop systems could have a similar thermal device. The thermal sensor asserts SMBALERT# if the processor temperature exceeds the temperature limits set in the Alarm Threshold Registers (T_{HIGH}, T_{LOW}). It also sets the corresponding Status Register bits to identify the cause of the interrupt. Figure 1 gives one example of the how the SMBALERT# signal could be used in a system.

Implication: There is no system impact from this erratum if temperature polling is used for processor thermal management. If the SMABLERT# interrupt is employed to manage processor thermal sensing, then servicing the false interrupt may result in premature system action depending on the software and hardware implementations used. The rate of the false interrupts is less than the auto-convert rate of the thermal sensor.
